**ENVIRONMENTAL SITE ASSESSMENT
TAVIS PROPERTY
28005 PACIFIC HIGHWAY SOUTH
KING COUNTY, WASHINGTON**

E-7816

September 23, 1997

**PREPARED FOR
GRANVILLE SOUTHERN CORPORATION**

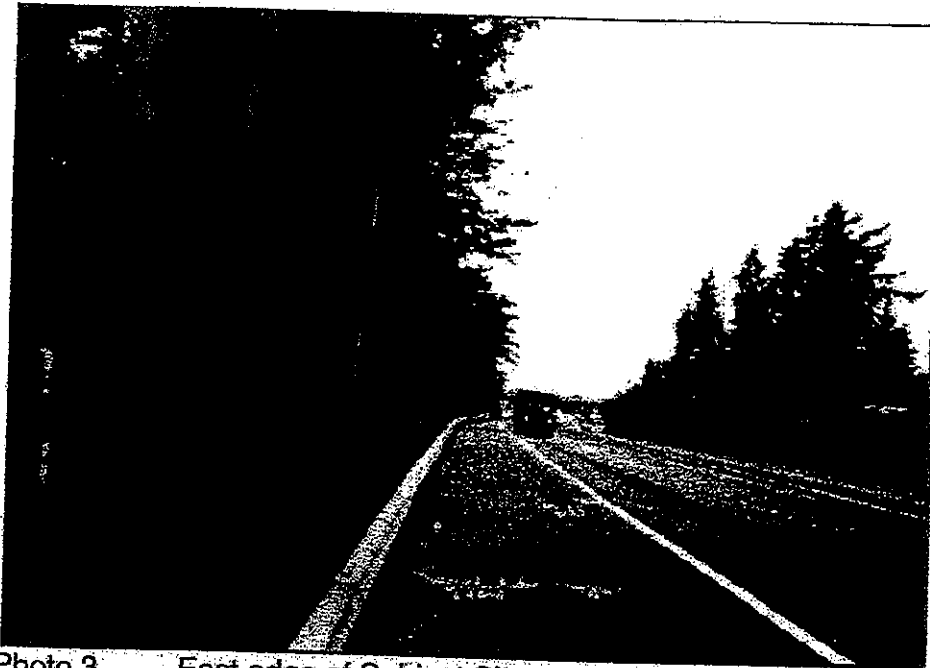
Photo 3 East edge of Subject Site and east adjacent properties.
Viewed south to north.

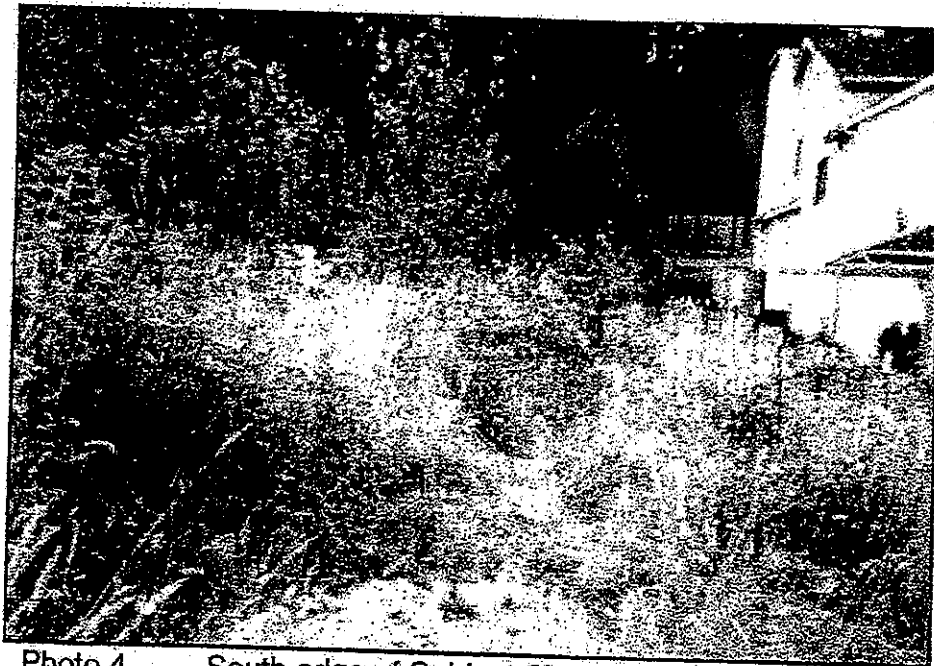
The subject property is bordered on the north and northwest by trees and vegetation on single-family residential properties (Photo 1 and 2). The subject property is bordered to the northeast by forestation and underbrush. The subject site is bordered on the east by multi-family residential apartment buildings across Pacific Highway South (Photo 3). The subject property is bordered on the southeast by forestation and underbrush. The subject site is bordered on the remainder of the south edge and the west by single-family residences (Photos 4, 5, and 6).

Photo 4 South edge of Subject Site and southeast adjacent
properties. Viewed west to east.

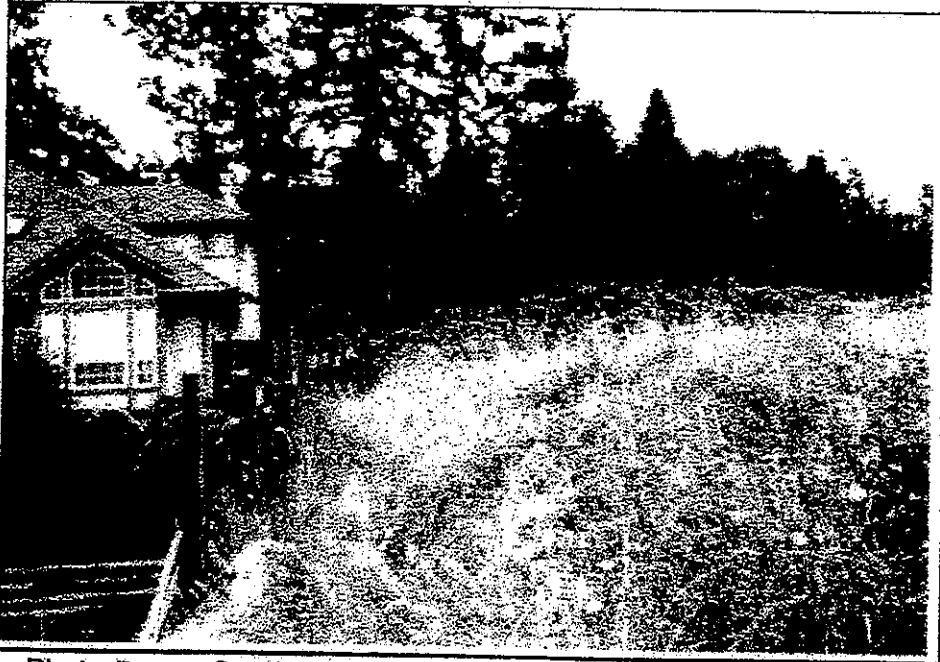
Photo 5 South edge of Subject Site and southwest adjacent properties. Viewed east to west.

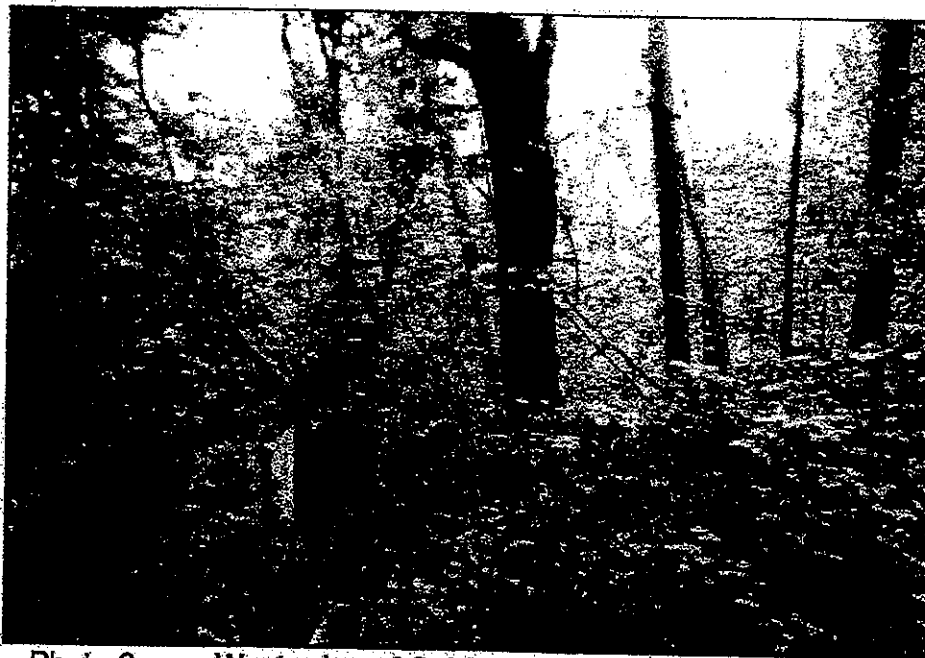
Photo 6 West edge of Subject Site and northwest adjacent properties. Viewed south to north.

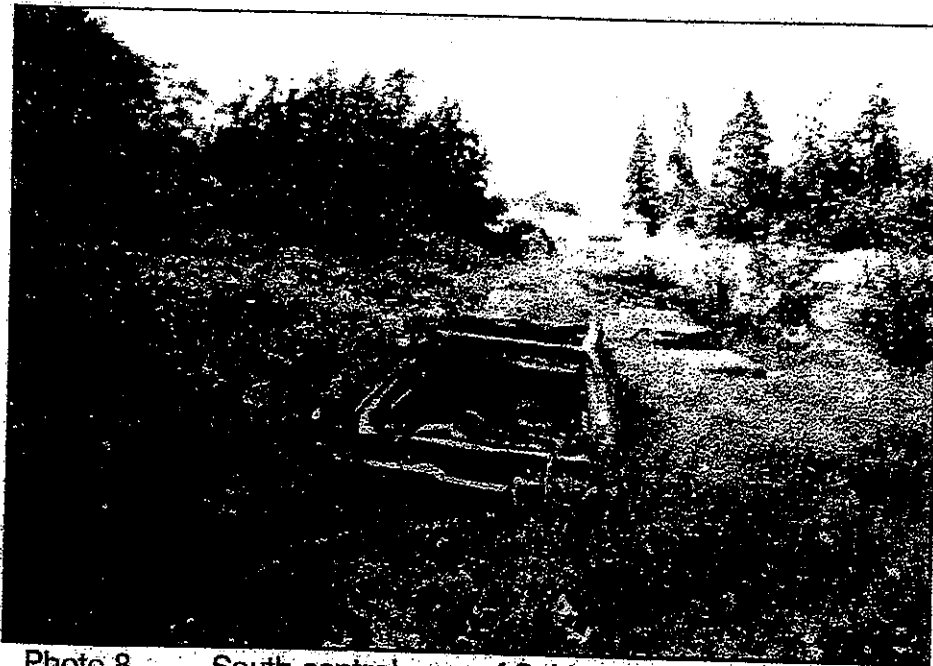
Photo 8 South central area of Subject Site. Viewed north to south. Fruit trees and abandoned vehicles along east side of central area. Photos Dated 7/30/97

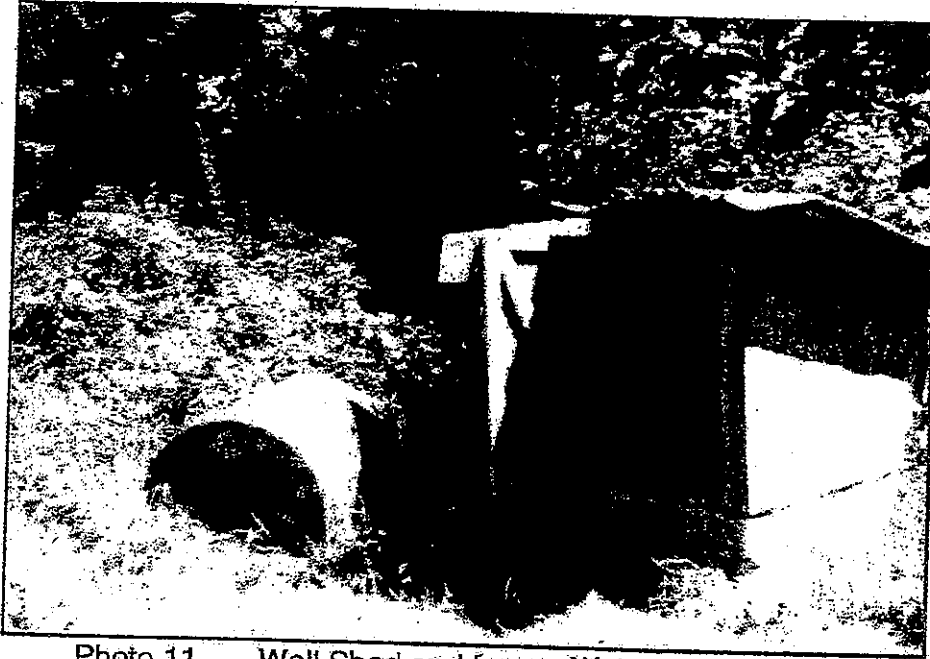
A water well covered by a small, wood-frame structure is located near the base of the east hillside at the east edge of the central property area (Photo 11). Mr. Tavis related in a conversation with ECI that he built the current structure over the well in approximately 1995. The well provided domestic water to the subject site from the late 1940s until approximately ten years ago when the water became non-potable due to an inflow of surface water from east adjacent properties. A large, above-ground, holed, rusted metal tank was observed next to the well house, and reported by Mr. Tavis to have been used for water storage.

Photo 11 Well Shed and former Water Storage Tank.
